Feedback on long-term integrity of Multi-linear drainage geocomposites installed on landfill final covers after 10 and 12 years of operation

Abstract. The use of drainage geocomposites in landfill final covers facilitates surface water drainage, contributing to long-term stability. However, validating their durability beyond accelerated laboratory aging tests remains a challenge. The most direct method involves exhuming geocomposites after prolonged field exposure and analyzing their mechanical and hydraulic properties. This study presents two case studies involving multi-linear drainage geocomposites installed in landfill final covers, one exhumed after 10 years in France and the other after 12 years in Canada. The samples underwent laboratory analysis to compare residual properties with original specifications, providing insights into long-term performance.

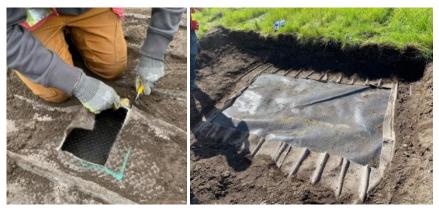
Fig. 10. A large sample is collected to be sent for laboratory testing.

- Careful soil removal to avoid damaging the underlying geomembrane.
- Manual exposure and sampling of the geocomposite.
- Endoscopic inspection of mini-pipes, revealing no clogging or deformation.

Preliminary inspection showed that while some roots were present in the geotextile layer, none had penetrated the mini-pipes. The liner remained clean after 12 years, with no clogging in the mini-pipes.

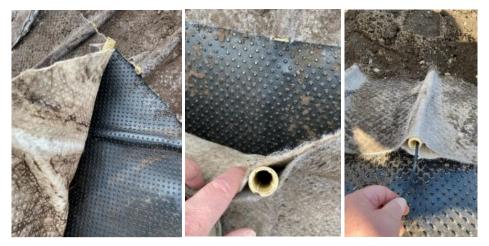
Fig. 11. Exposition of the geocomposite and the liner. Endoscopic inspection of the mini-pipes.

An endoscopic camera was inserted into each mini-pipe to assess internal conditions, confirming no deformation, root intrusion, or debris accumulation. The geocomposite maintained stable flow conditions, demonstrating the effectiveness of its geotextile filter.

Following exhumation, repairs were conducted by installing a new section of multi-linear drainage geocomposite, reconnecting mini-pipes using couplers before backfilling the area.
