## Exposed NPNW GT Performance at a Large Surface Impoundment For Nearly One Year

Exposed needle punched nonwoven (NPNW) Geotextiles are uncommon in Civil Engineering applications. Most specifications limit their exposure to a few weeks after installation due to the threat of UV degradation. This very unusual case history allowed us to evaluate an exposed NPNW geotextile over a long period of time (8 months). In addition, we performed laboratory UV exposure tests to counterpoint field versus lab performance and develop correlations between different methods of exposure.

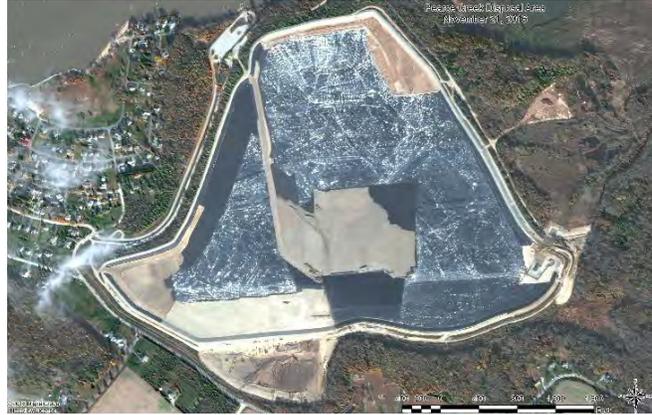
**Figure 2. Aerial photograph of the site**

The site is operated by the U.S. Army Corps of Engineers (USACE) and is identified as the Pearce Creek Confined Disposal Facility, which receives dredge sediment from the Chesapeake and Delaware (C & D) Canal southern approach channels. The C & D canal is shown on the map in Figure 1 and the site location is identified by a star. Figure 2 shows an aerial view of the dredge disposal facility. This facility is in the Mid-Atlantic region of the USA just outside of Wilmington Delaware. The site’s closest town is Elk Neck, Maryland, with a longitude and latitude of 39.4848° N, 75.9848° W.

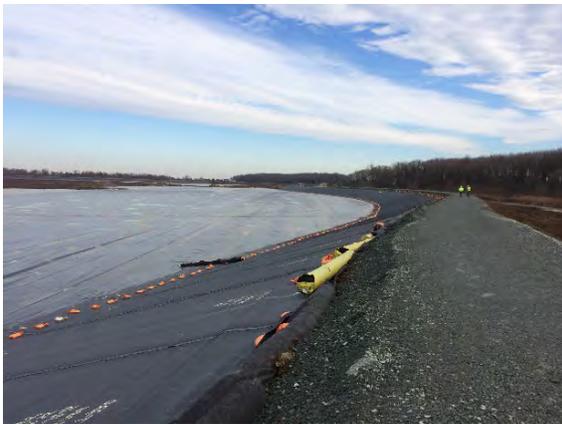
**Figure 3. Site photo of deployed geotextile**

Geotextile samples were taken in the field at the beginning of the project after 85 days of exposure and then finally after 252 days of exposure. A site photograph of the geotextile being deployed is shown in Figure 3. Figure 4 shows geotextile samples being taken at 85 days.

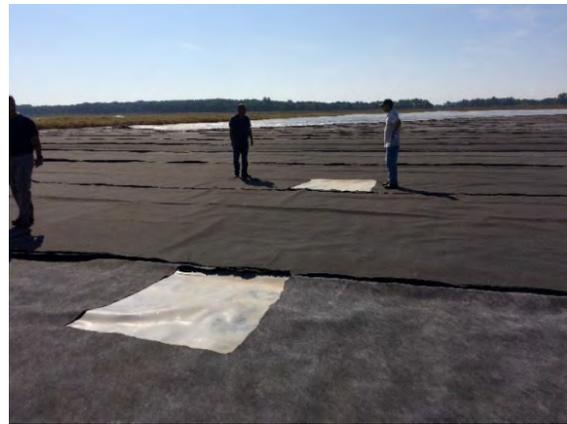
**Figure 4. Photo of geotextile being sampled**

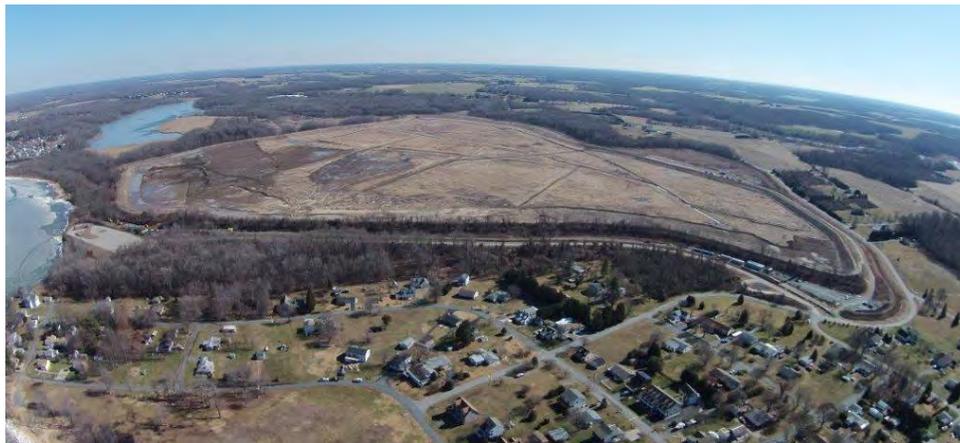
**Figure 6. Aerial photograph of the Pearce Creek Disposal Facility**

Figure 6 shows an aerial photograph of the completed project.

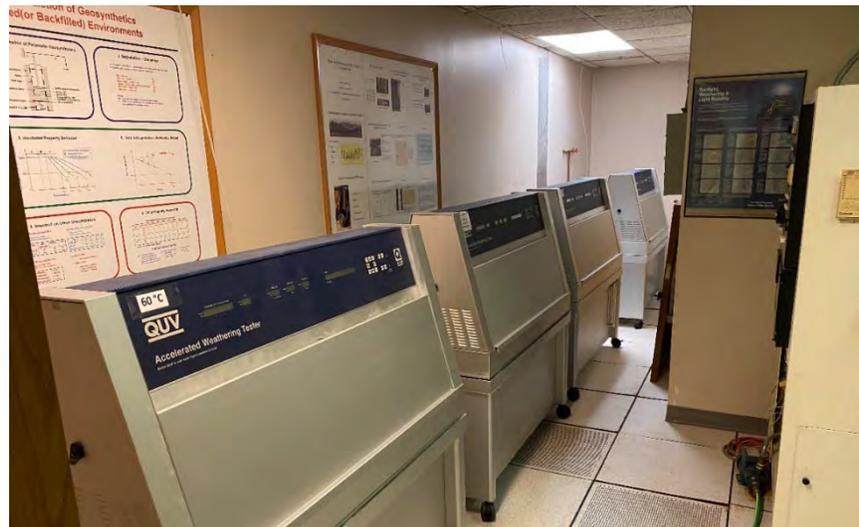
**Figure 9. Photograph of the weathering durability lab at the Geosynthetic Institute (GSI). Note, four UV accelerated weathering apparatuses on the left and a single Xenon apparatus on the right**

The xenon arc and UV accelerated weathering testers are the most commonly used accelerated testers. The equipment cross-sections are shown in Figures 7 and 8 respectively. GSI's UV exposure room is shown in the photograph of Figure 9.
